SERVICE INFORMATION

STANDARD AND TRIUMPH VEHICLES

No.	EIGHT/19/N	TYPE OF PAINT TO BE USED FOR RE-FINISHING AND RE-TOUCHING	Date	DECEMBER 1955
------------	------------	--	-------------	---------------

No.	SPORTS/8/B.	ROCKER COVER GASKET	Date	JUNE 1955
------------	-------------	---------------------	-------------	-----------

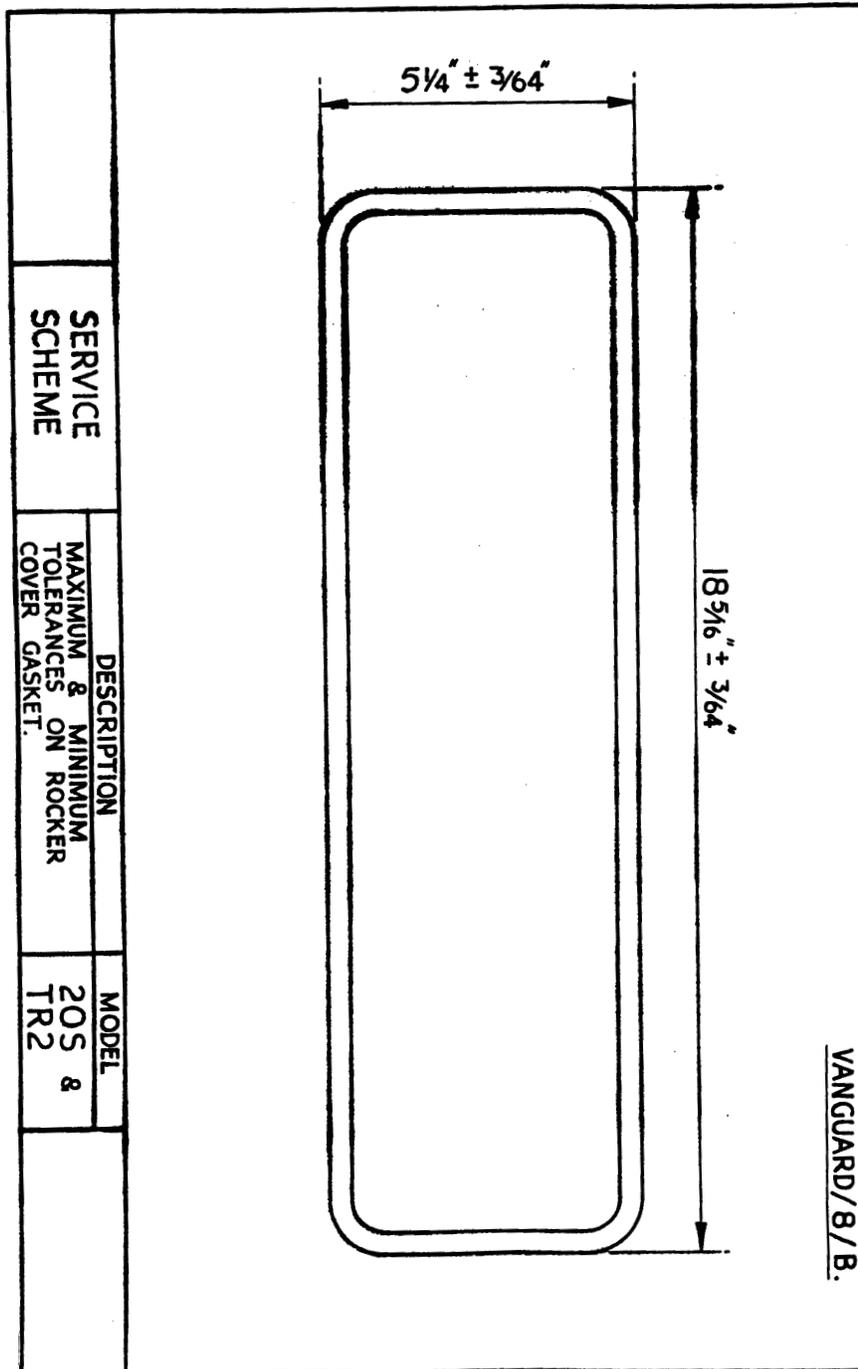
1 ILLUSTRATION

Reports of oil leakage past Rocker Cover Gasket, Part No. 55943, have been investigated. It has been found that certain consignments of gaskets received from our suppliers have been cut from cork materials which had an excessive moisture content. As a result, when this moisture content dries out, the gasket material shrinks either after fitting on the engine or during long periods of storage.

In order that gaskets may be checked for size, before fitting to an engine, the correct dimensions are given in the illustration.

Packages of gaskets now being received are marked with the letters "TD" on the wrapping, denoting that the moisture has been dried out of the cork material by Tunnel Drying before cutting.
