STANDARD-TRIUMPH MOTOR COMPANY, INC.
WESTERN ZONE

TO: ALL TRIUMPH DEALERS - WESTERN ZONE

DEPT: SERVICE AND PARTS

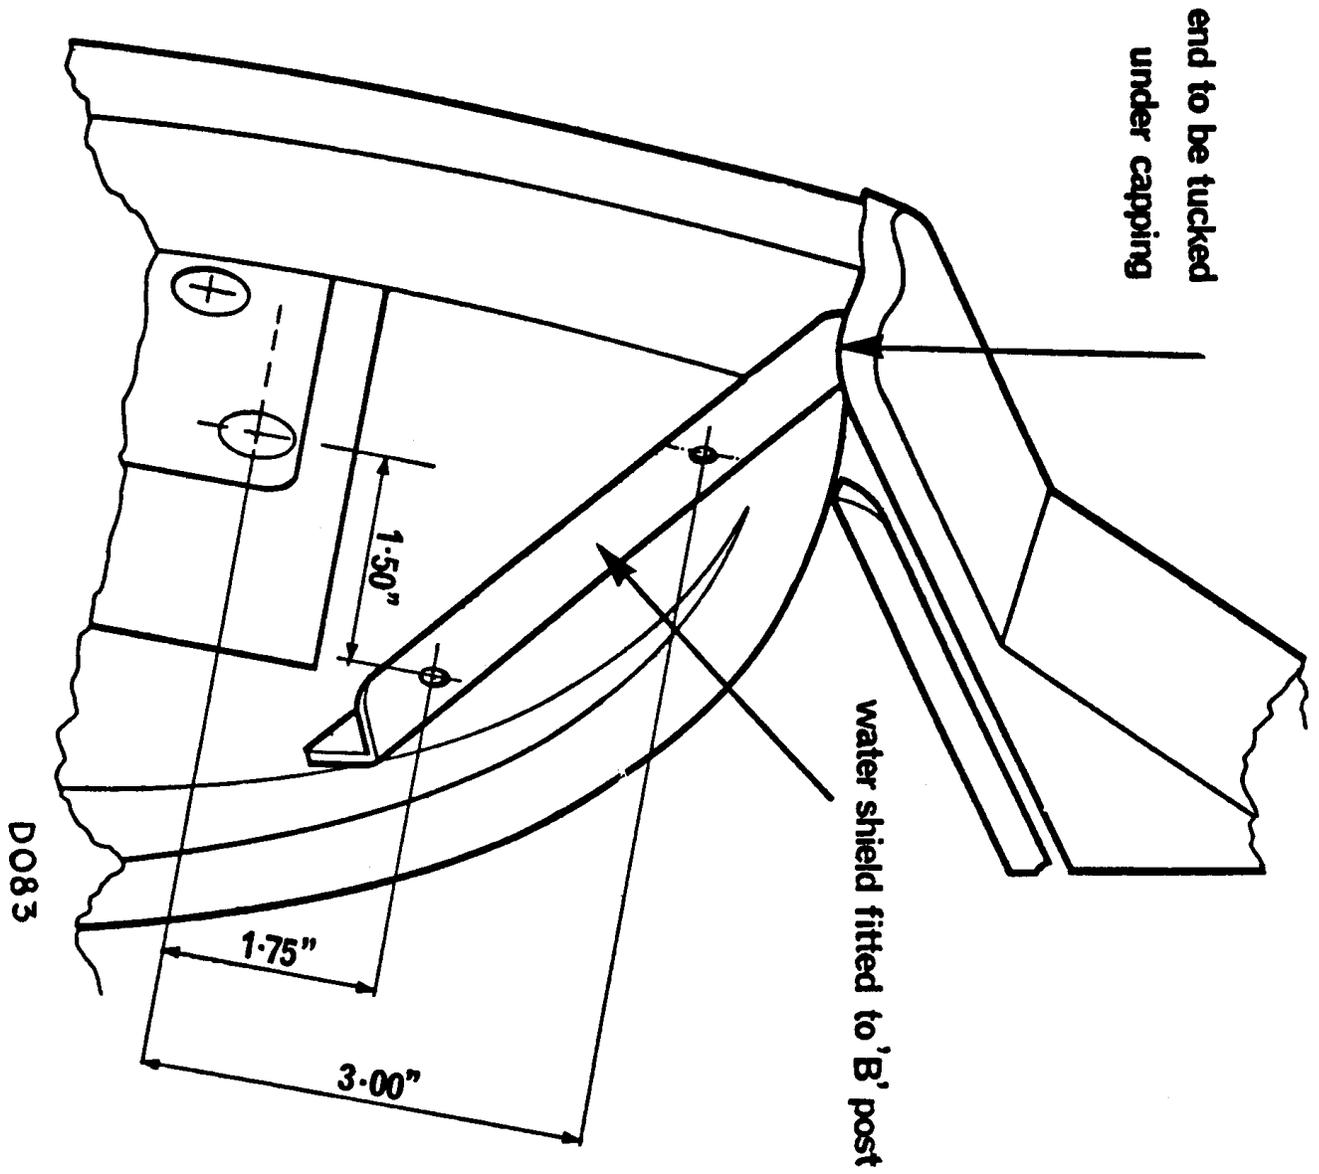
To eliminate possible water entry into the body, rubber shields have recently been fitted to the forward face of the "B" posts on Spitfire models.

These shields, part numbers 569241 L.H. and 569242 R.H. are pop-riveted in position with 1/8" dia. Imex rivets AD46, as shown in the illustration.

All cars in service prior to the introduction of this scheme should be modified to the above condition.

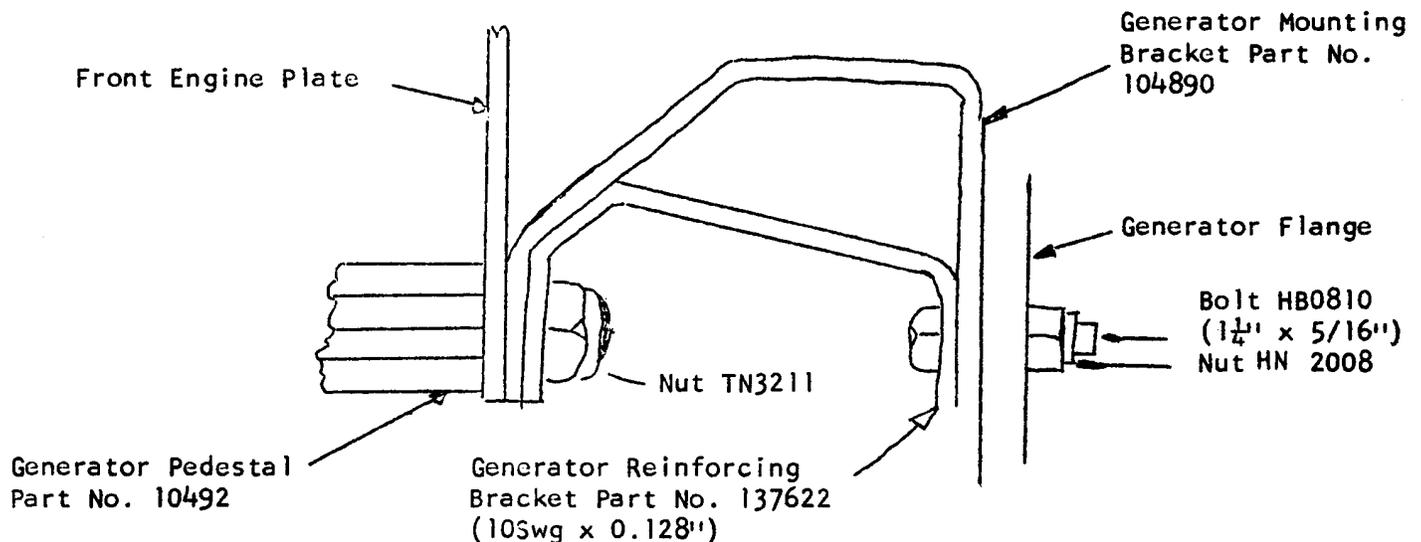
Should a failure of the generator mounting bracket occur on any of the above models, the bracket should be replaced by the following details which include an additional reinforcing bracket.

The diagram shown below illustrates the location of the additional reinforcing bracket.

The reinforced bracket was introduced on production at the following engine numbers: GA-117163-E, GC-9042-E and FC-12035-E.

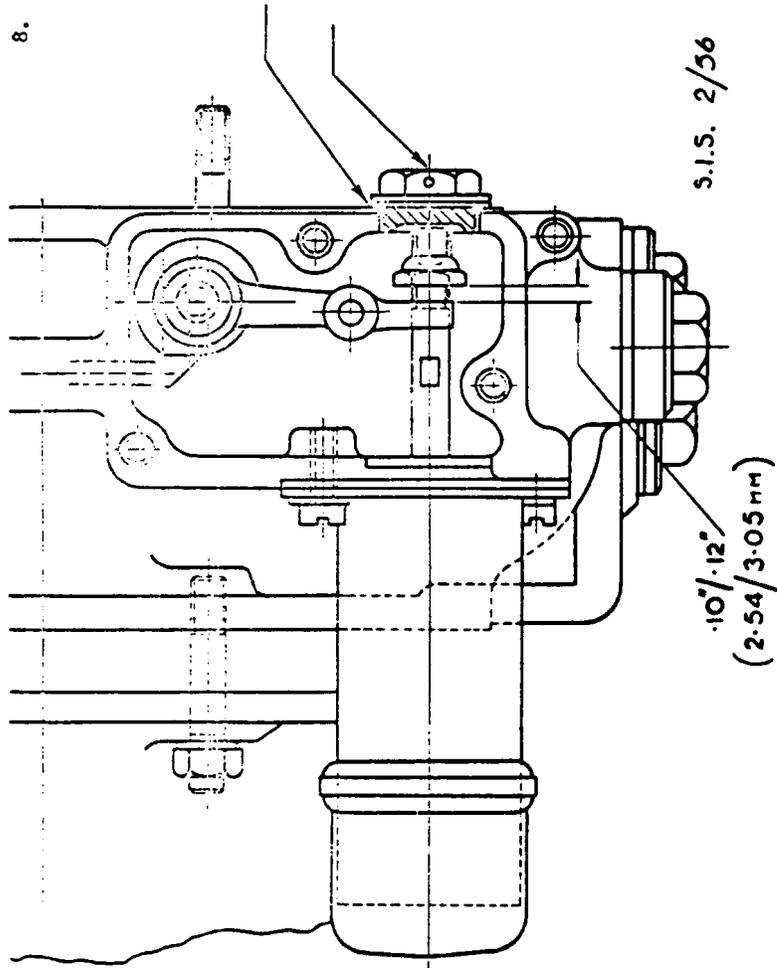
2. Remove faulty solenoid.
3. Remove the existing hexagon headed plug and replace it with the new recessed plug. This will reduce the excessive free movement of the solenoid plunger.
4. Insert a 3/16" (4.76 mm) diameter peg or drill shank through the valve operating lever locating the lever with the hole in the casing.
5. Energize the solenoid.
6. Adjust the solenoid shaft nut until its face is flush with the operating lever.
7. Remove the peg or drill and switch off the solenoid.
8. Reoperate the solenoid and make sure that the hole in the lever lines up with the hole in the case.
9. Check with the ammeter connected between the solenoid and main feed wire to ensure that the solenoid points open when operated. The current should read approximately 2 amps.

Washer
Part No. 513382

Plug
Part No. 513381
