TO: ALL TRIUMPH DEALERS - WESTERN ZONE

BULLETIN T-64-1

SUBJECT: SPITFIRE SPEEDOMETER CABLE RUN

SUBJECT: LAYCOCK OVERDRIVE

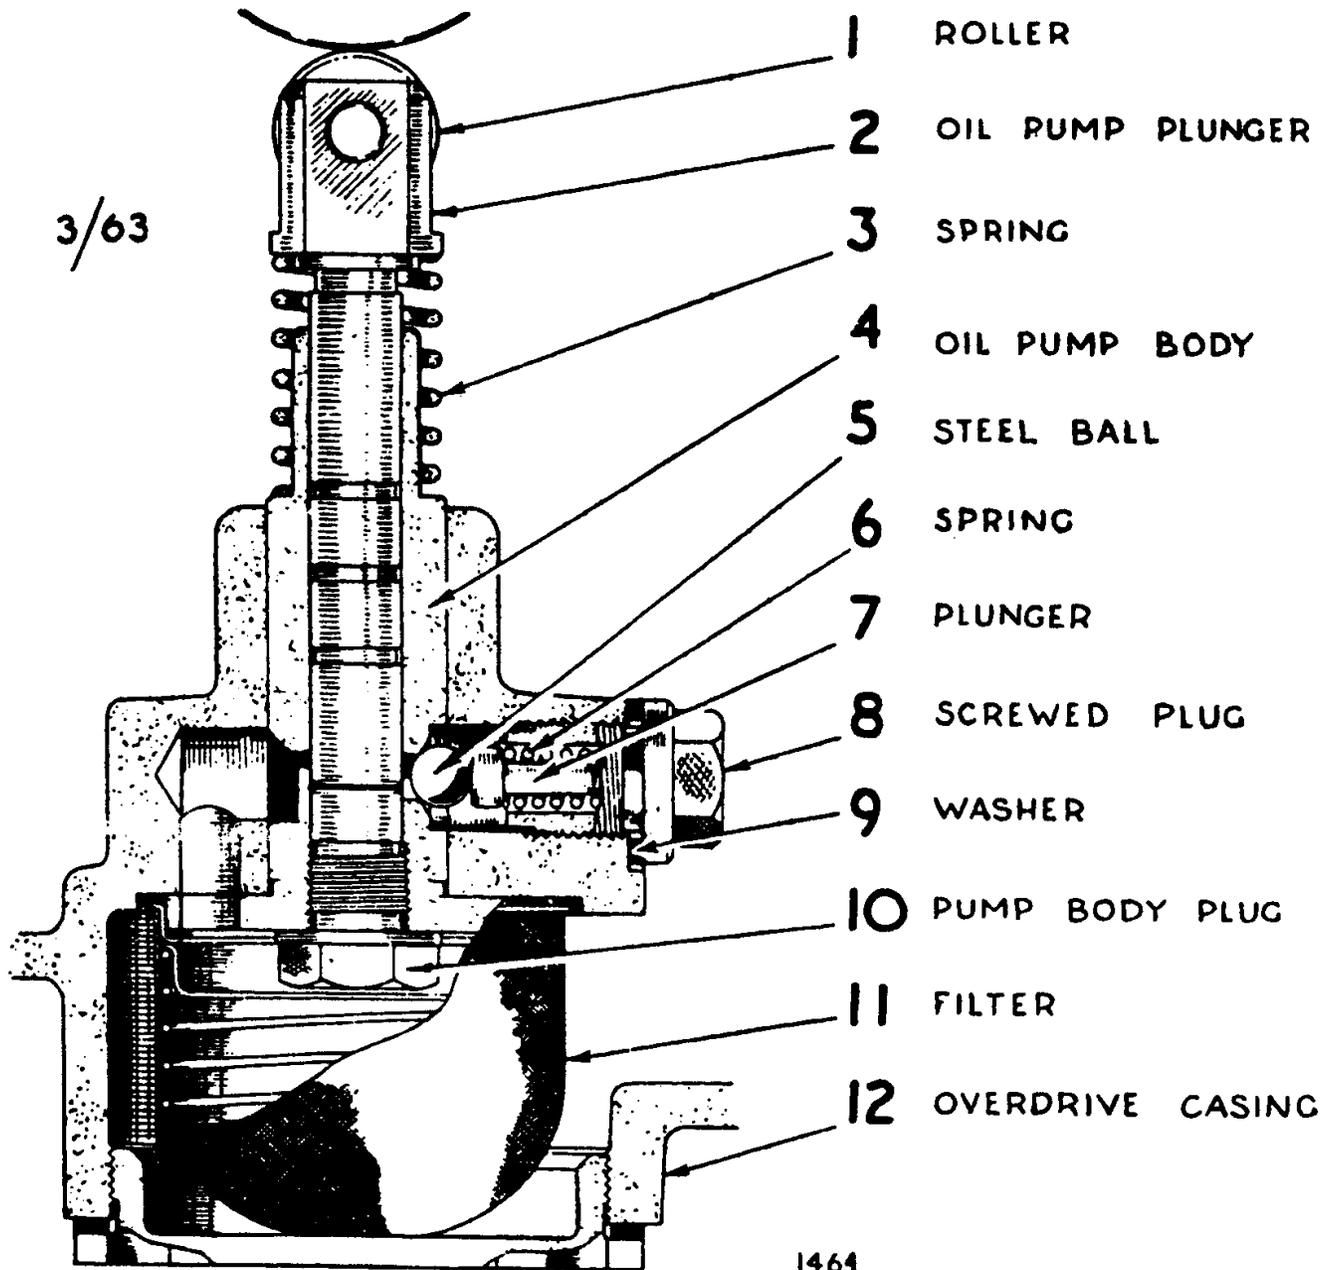
FIG. 1

- 1.. Insufficient oil in unit.
2. Solenoid not operating due to fault in electrical system.
3. Solenoid operating lever out of adjustment.
4. Insufficient hydraulic pressure due to pump non-return valve incorrectly seating (probably dirt on seat).
5. Damaged parts within the unit.

For adjusting the solenoid on "D" type see Service Bulletin 1-63-60. PUMP NON-RETURN VALVE (Figure 1)

PUMP VALVE
A TYPE ONLY

In "A" type units access to the valve necessitates removal of the solenoid and solenoid bracket. The bracket is secured by two 5/16" (7.937 mm.) diameter studs and two t/16" (7.937 mm.) diameter bolts, the head of the bolts being painted RED. THE NUTS MUST BE REMOVED FROM THE STUDS BEFORE TOUCHING THE BOLTS. The two bolts should not be slackened off together releasing the compression on the accumulator spring which abuts the solenoid bracket.

After removing the valve plug, spring, plunger and ball, clean the seat and reset the ball by giving it a sharp tap with a suitable hammer and drift.

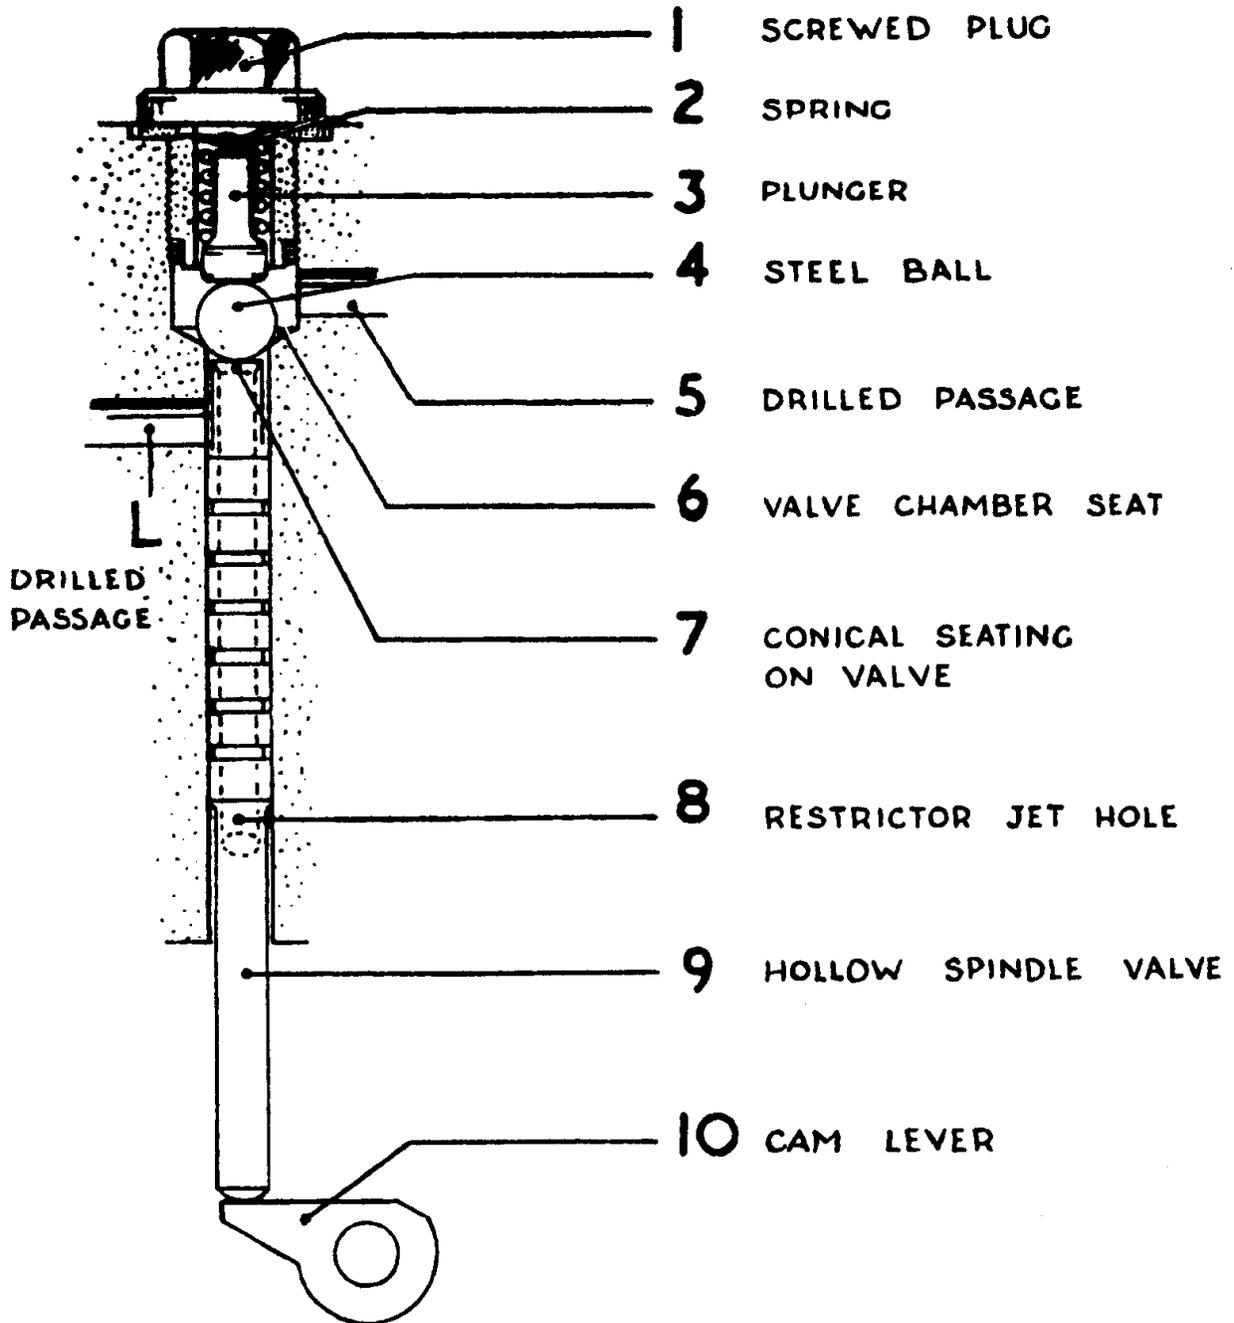
FIG. 2

The operating valve plug is located on top of the unit. Release hydraulic pressure, unscrew plug and remove spring, plunger and ball. A small magnet will be found useful for this operation. Remove operating valve by inserting a stiff piece of wire and drawing it up. Near the bottom of the valve will be seen a small hole breaking through the center drilling. Ensure that this is not choked (Figure 2).

OPERATING VALVE
A AND D TYPE

If necessary, the ball can be resealed on top of the operating valve by placing the ball on a block of wood and sharply tapping the valve after positioning it on the ball. Clean the valve seat in the casing and if necessary reseat the ball by tapping it gently on its seat with a copper drift. Do not tap the ball too hard or the mouth of the hole will be closed up so that the valve cannot be reassembled.

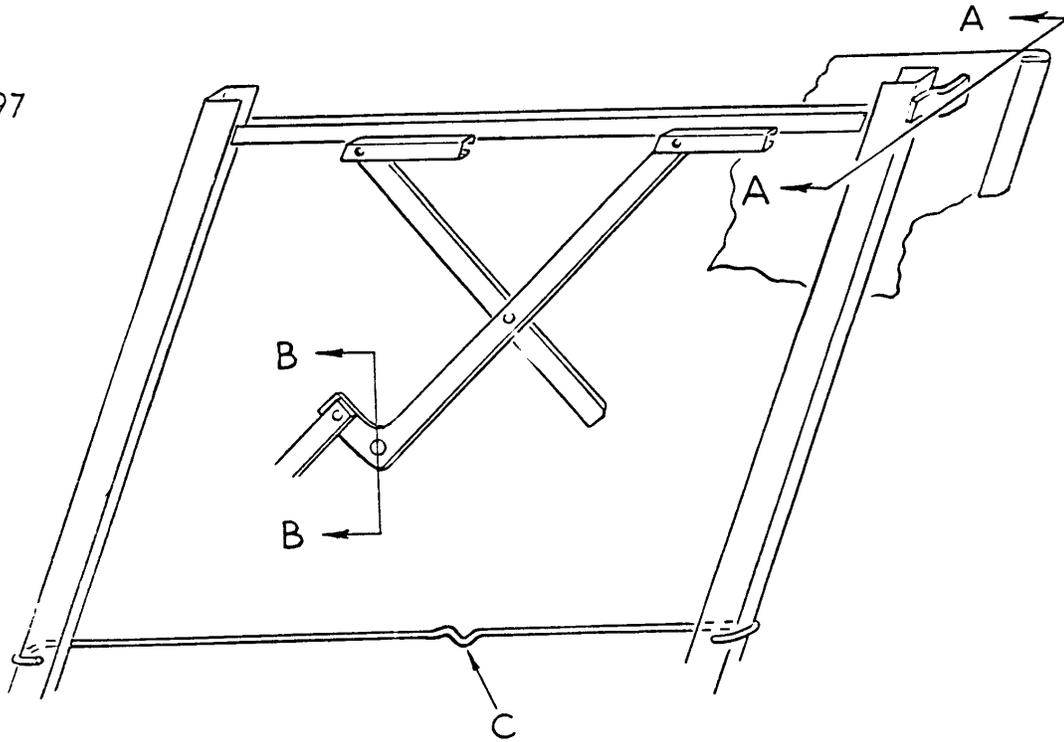
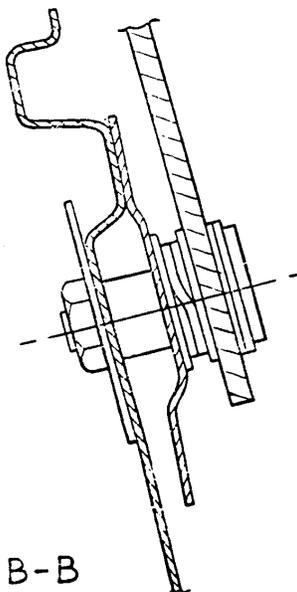
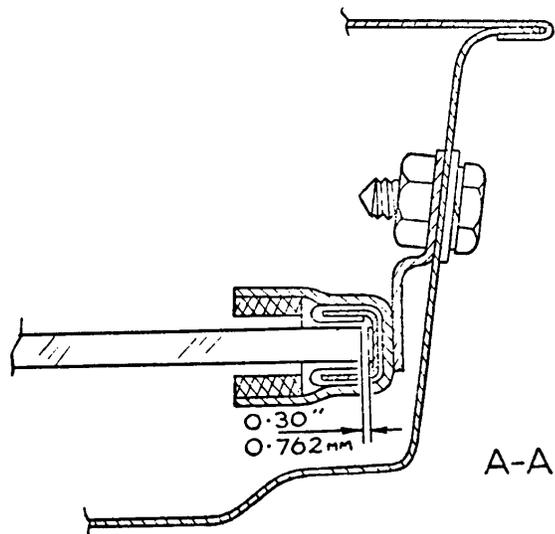
A-A

When reports of stiffness in the operation of the door glass are received, the following procedure should be adopted which will prevent straining and damage to the regulator. The same instructions should also be followed when renewing a regulator.

1. Remove trim panel.
2. Raise window and check the clearance of the glass fore and aft in the top of the rear channel. The recommended clearance is .030" which should be maintained for the whole length of the channel. Excess clearance will allow tilting and the jamming of the glass and insufficient clearance will produce stiff operation. Clearance can be obtained by the use of packing washers between the inner door panel and top channel bracket (see illustration A-A).
