**JUDGING STANDARDS &
RESTORATION GUIDELINES**

Triumph Register of America

Judging Standards and Restoration Guidelines

February 1993 Edition
May 2004 Revision

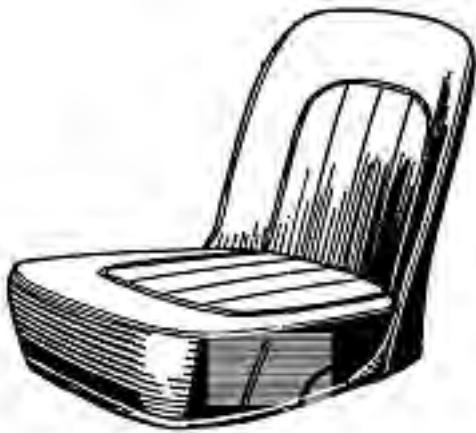
TS 1 through TS 22013

1. **Seat Upholstery Pattern** - There were two major patterns of seat upholstery, with TS 22013 being the changeover point. AT TS 8637 (?) the front of the cushion was changed from a sloping or bevelled shape to a vertical one, and there may have been some changes to the internal assembly of the seat which is not noticeable. The two major patterns are illustrated below, courtesy of The Roadster Factory.
