STANDARD-TRIUMPH MOTOR COMPANY, INC.
WESTERN ZONE

TO: ALL TRIUMPH DEALERS - WESTERN ZONE

DEPT: SERVICE AND PARTS

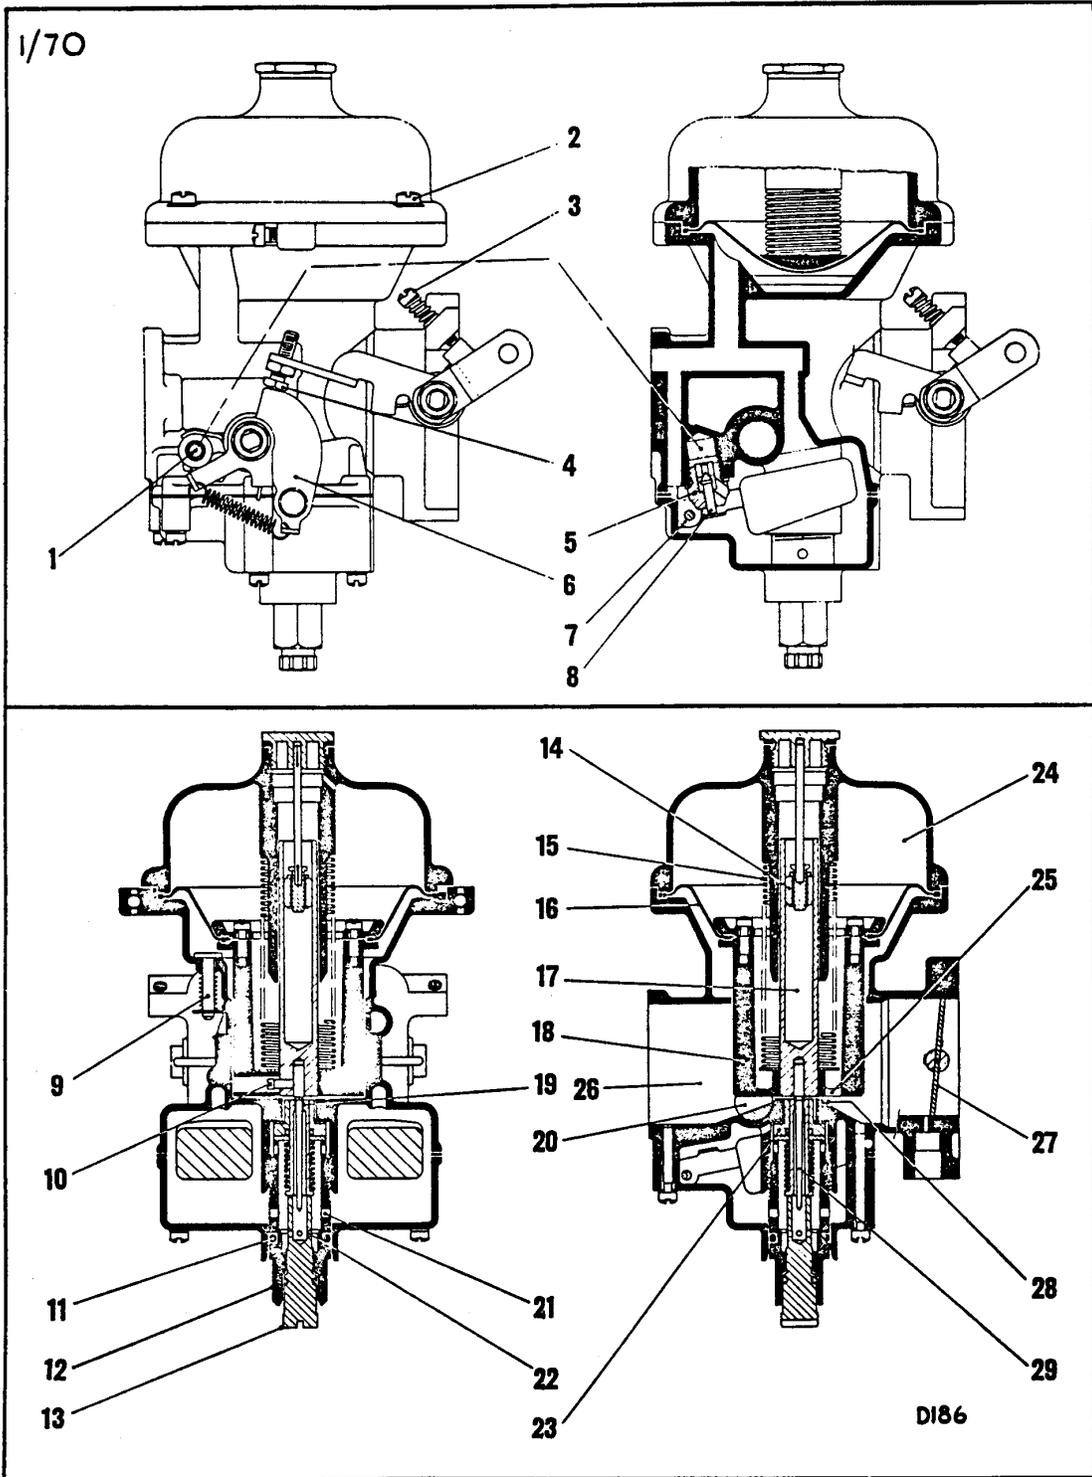
If the suction chamber cover is removed, it must be replaced so that the screw holes line up with those in the main body and the diaphragm is not disturbed.

The air valve rod and guide must be kept clean with minimum handling when removed to avoid corrosion and a few drops of light oil applied to the rod when refitting.
